UHF
Ultra-High Frequency Transducers

Aplio i-series

Ultra-High Frequency transducers

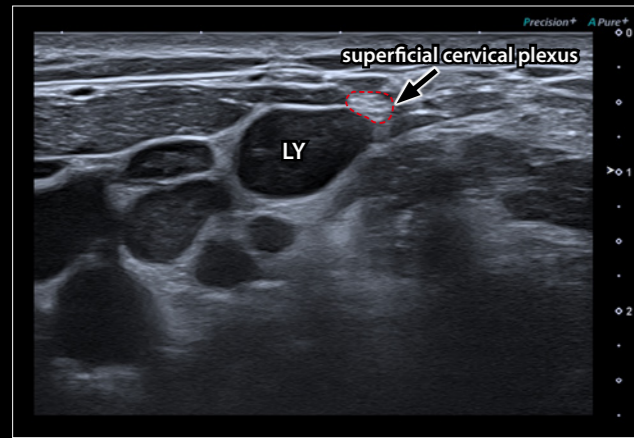
This case is a female patient with swollen lymph nodes in the neck. She underwent a left Level V lymph node dissection one months ago. The patient had a left neck pain and weakness of the left shoulder. Then she was referred for an ultrasound scan of the left neck. The detailed B-mode of the 24MHZ probe revealed that superficial cervical plexus was compressed by a swollen lymph node (**Fig. 1**). The left accessory nerve presented swollen and Power Doppler signals were detected within the nerve (**Fig. 2**). Further, the scar of surroundings branch of the accessory nerve was detected (**Fig. 3**). The classification of peripheral nerve injury is an important basis for clinical treatment. The high resolution ultrasound can provide important morphological basis for accurate clinical diagnosis and treatment.

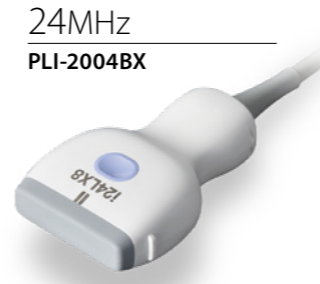
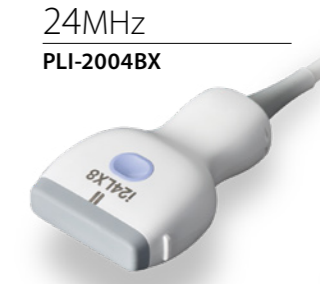
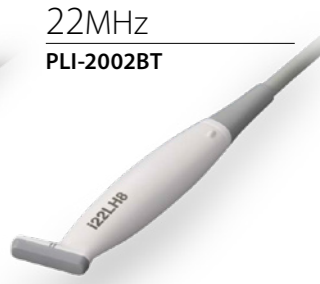
Muscle injuries in sport are common, often result in games missed and can have a high recurrence rate. The use of high frequency ultrasound imaging is an excellent addition to the return to play decision making process. In this case study, an MRI initially diagnosed a second-degree rectus femoris muscle injury. Ultrasound imaging using a high frequency probe was then performed serially based on a proposed protocol by Hall (2018)*. The images at 4.5 weeks (**Figure 1**), 5.5 weeks (**Figure 2**) and 6.5 weeks post-injury (**Figure 3**) are shown below. Resolution of the anechoic fluid/hematoma associated with healing was progressively seen and indicated the rehab activities were appropriate. Dynamic isometric muscle contraction was observed to improve over the injured tissue over time, indicating progressive scar formation. In conjunction with functional and clinical testing, the addition of ultrasound imaging helped guide the return to play protocol progression.

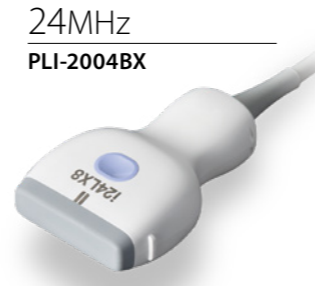
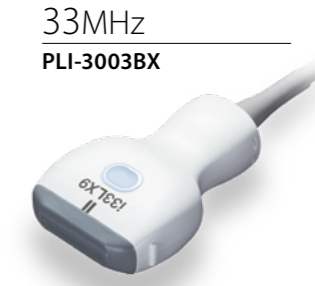
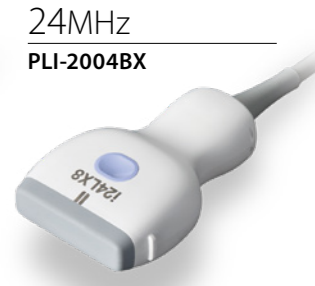
This is a case from a patient with angiosarcoma of the face. After radiation therapy, the surface of the skin looked normal so the attending doctor considered the tumor had completely disappeared. However, a small hypoechoic area beneath the skin surface was detected during follow-up ultrasound (**Fig. 1**). By using the 24MHz transducer (**Fig. 2**), SMI did not show much flow signals, suggesting necrosis or scarring of the lesion. The treatment would be considered as successful and radiotherapy would be terminated. However, rich vasculature was detected using 33MHz (**Fig. 3**), strongly suggesting a residual tumor.
